# The Rest of the Story For the RotorWay Community

By Matthew Dock, P.E.

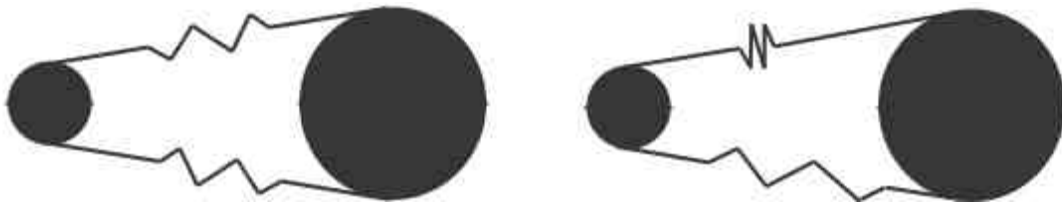
Figure 1. Results of adding torque to a belt drive, Left-no torque, with preload Right-torque applied

This is also one of the reasons that preload plays a minor role in the failures. Let us take an extreme example of a system with 500 lbs of pretension. The system starts with 500 lbs of preload on each side of the belt drive, distributed over the two springs shown in Figure 1. Now, we want to transfer power from the driver to the driven pulley, so, we have to increase the tension on one side of the system. So, we know that we need to have around 1600 lbs of belt tension to get off the ground. As we begin raising collective the tension on the tight side increases, causing the belt to stretch. As the belt stretches there is more belt available on the slack side, reducing the tension on that side, causing the system to get loose, exactly as shown using the cog belt fixture at Homer's 2004.

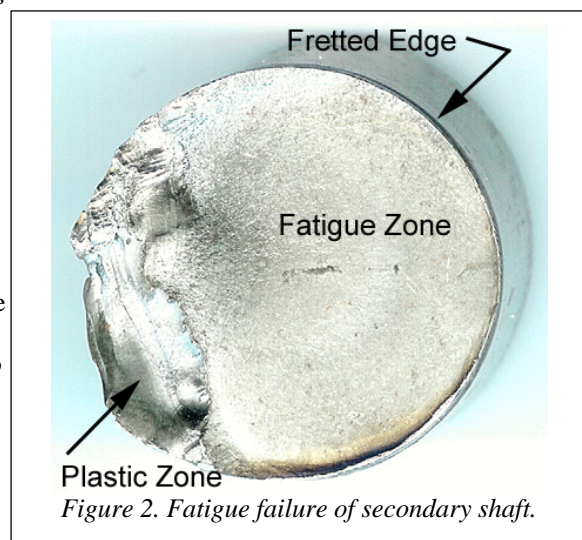
Jack Kane has written a lot about my stance that stress doesn't matter. Jack is again using his creative writing skills to transfer importance away from real issues. Stress does not matter in this case because the failures are not due to high stress. The failures always start at the fretted edge as shown in Figure 2. The reason that the stress isn't the issue is that the shaft is much larger than it needs to be to support the loads imposed. Look at Figure 2 and notice the amount of material remaining when the part finally breaks (plastic zone). The shaft begins to break due to a small crack in the fretted edge. That crack then propagates across the surface, reducing the size of the shaft as the crack grows. So, with every cycle the crack grows a little farther, reducing the area available to hold the shaft together. As the shaft's area decreases the stress grows, finally causing the shaft to

break all at once across the plastic zone. So, just look at the relative area of the plastic zone and the total area of the shaft, it shows that the part is approximately five times bigger than is necessary to support the load of the cog belt or chain. So, stress is important, but in the case of why does the shaft fail, it simply doesn't matter.

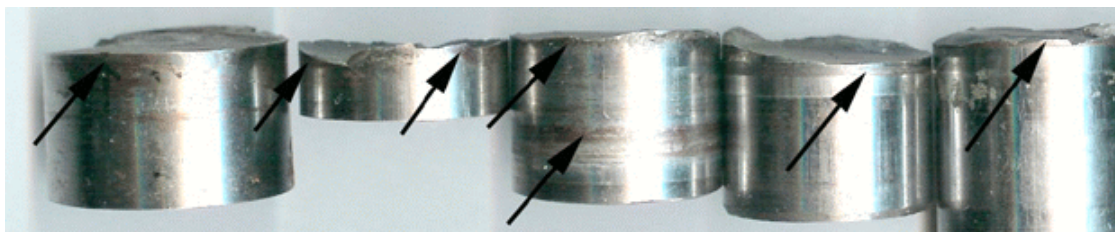
Here is the real problem, engineers take a large amount of information, from different sources, apply their experience and understanding of the problem, and come to conclusions. In most cases, what you are hearing from Jack and I are our conclusions. I said in March 2000, five years ago, that the problem was fretting, which leads to fatigue failure. Now, maybe everyone has followed the math, calculations, horsepower discussions, etc, however the conclusions are the same, broken shafts have fretting corrosion. See Figure 3.

*Figure 3. Broken shafts*

Every broken secondary shaft that Pro-Drive and I have reviewed has shown fretting corrosion as the initiator of fatigue cracks that lead to failure. If the part has failed, the failure starts in the fretting. It is that simple, every time a shaft breaks, the failure starts in fretting. Therefore, if you eliminate the fretting, how is the shaft going to break? What is important is that the fretting failure mode is identified and eliminated.

The real question comes down to designing the shaft so that fretting is eliminated. If the shaft does not exhibit fretting, it should last forever. Jack Kane has jumped on a number of statements that I made at Homer's. Mainly, does Jack's design have the required toughness required? He talks about different numbers, but if you look on the Pro-Drive website it clearly shows toughness values. If you read his website, and read very carefully between the lines, you can see that the 9310 material has SIX times the IZOD toughness. Jack says his material is tough enough, fine, we will all learn over time. I also asked if the material that Jack had selected (300M a modified 4340) was hardenable to the point it could be used in the sprag clutch. Again, if Jack is comfortable with changing from a surface carburized 9310 with surface hardness near Rc 60 to a modified 4340 that is full heat treated through the core, then fine. John Spurling and I actually discussed changing to 4340 but decided the risk of an entire new material, with all of the new issues involved, was a bad idea. It may turn out to be a good design, but we won't know until a large number of ships get hundreds of hours with a lot of autorotations.
